PROPERTY CONDITION REPORT

4140-4146 N. Fremont Ave.
Minneapolis, MN
October 23, 2015
Terracon Project No. F2158516

Re: Property Condition Report
4140-4146 N. Fremont Ave.
Minneapolis, MN 55412
Terracon Project No. F2158516

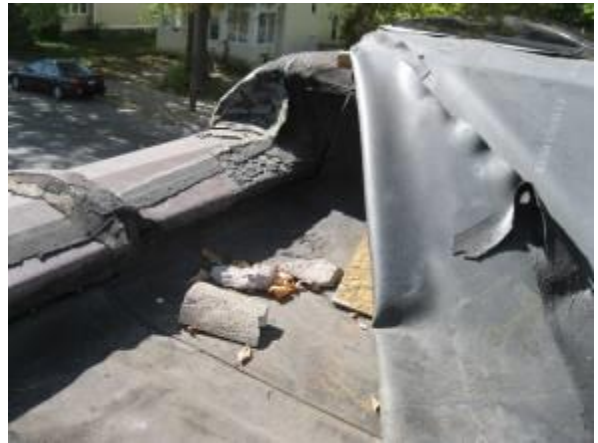
Photo #4 Failed and improper roof repair at southwest corner.

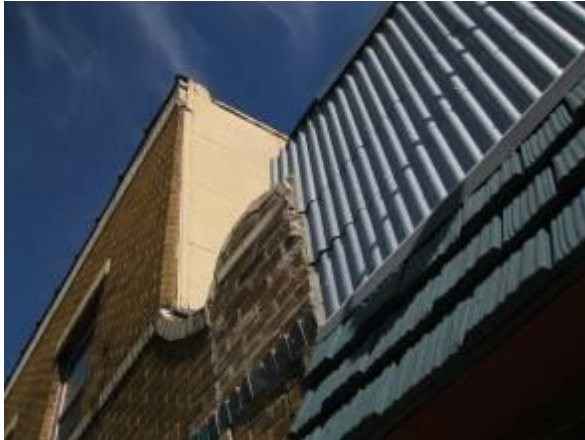
Photo #7 Deteriorated mortar joints at low-to-high transition along west side.

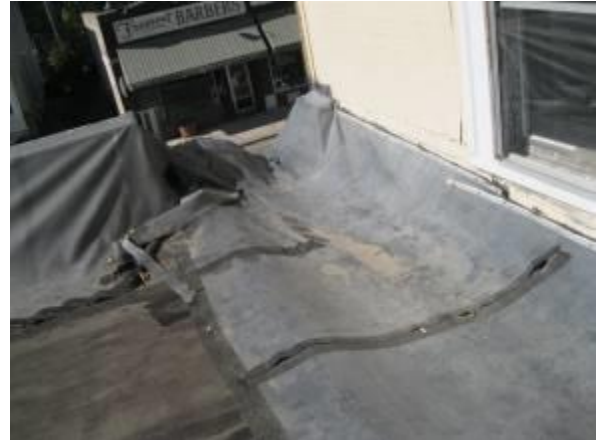
Photo #8 Holes in improper roof repair at low-high transition along front parapet.

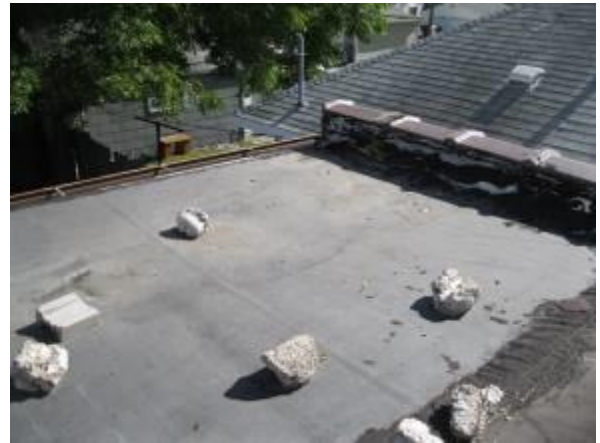
Photo #10 Membrane repair and failed parapet flashing in southeast corner above 4140.

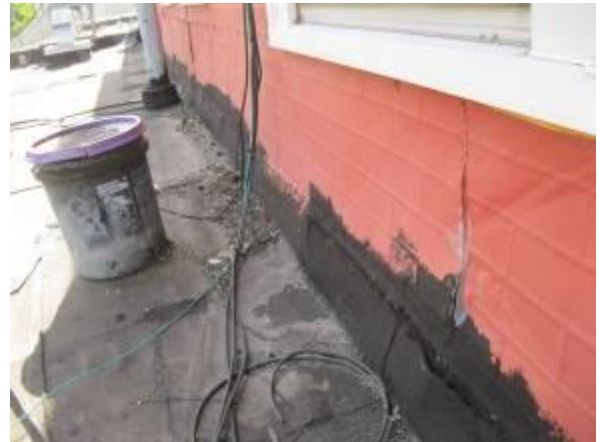
Photo #14 Improper flashing termination; gaps and dents in metal panels.

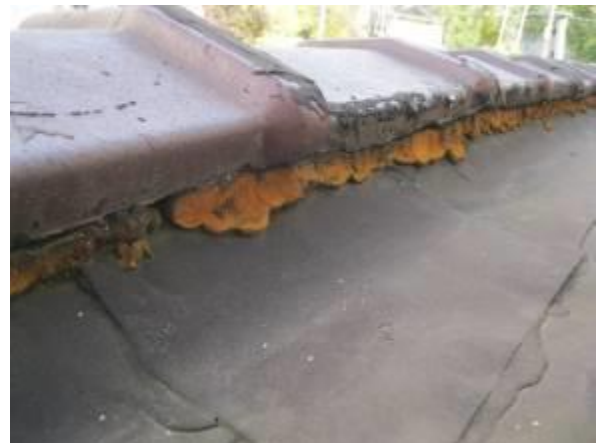
Photo #16 Improper flashing termination along north side bell-style copings on shared wall with building to the north.

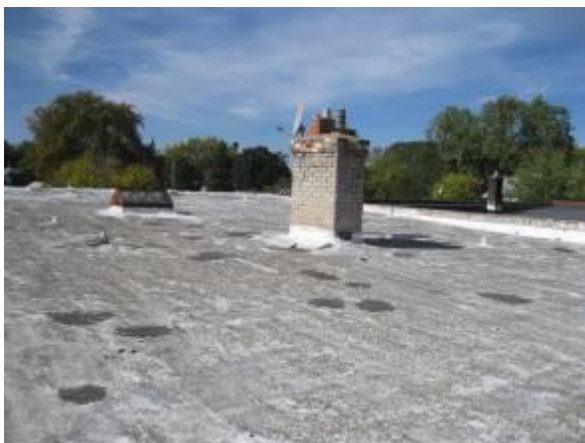
Photo #17 Spray-foam roof over 4144-46; deteriorated masonry at chimney.

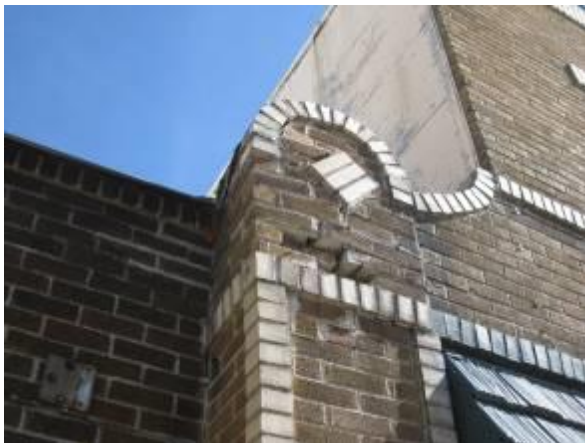
Photo #21 Deteriorated masonry at northwest corner of 4144-46; abutting building to the north shows darker red brick.

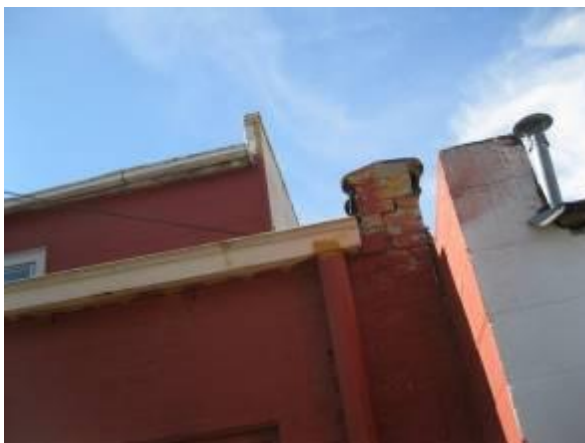
Photo #23 Deteriorated masonry at northeast corner parapet.

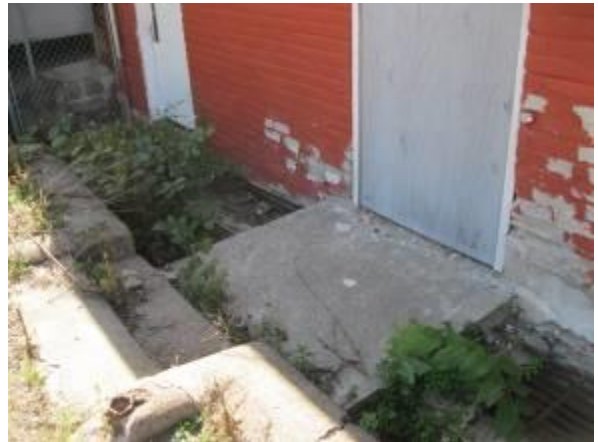
Photo #26 4144-46 rear access doors all lower than adjacent parking area; potential for trapped water adjacent to foundation.

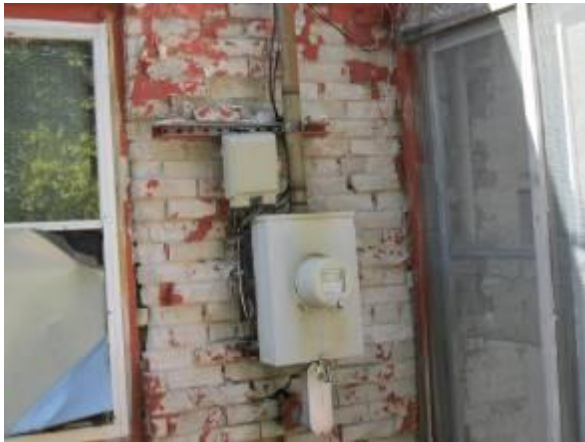
Photo #31 Deteriorated masonry and window jamb near 4142.

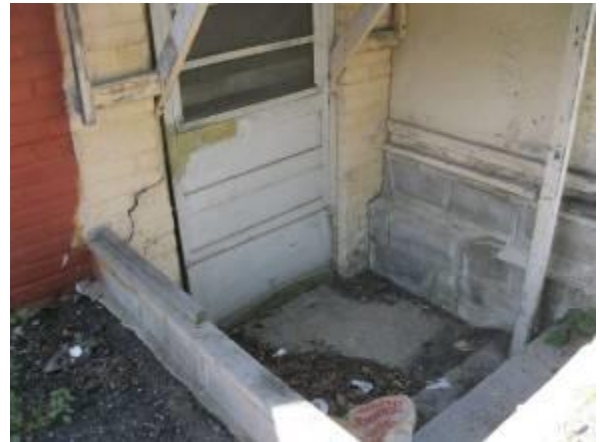
Photo #32 Cracking at masonry at rear access to 4140.

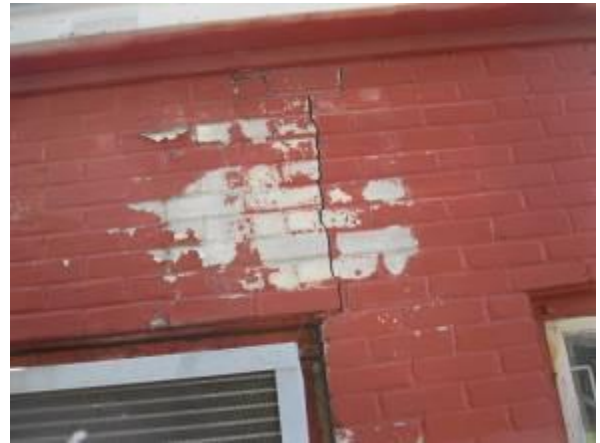
Photo #34 Cracked masonry at rear of 4140.

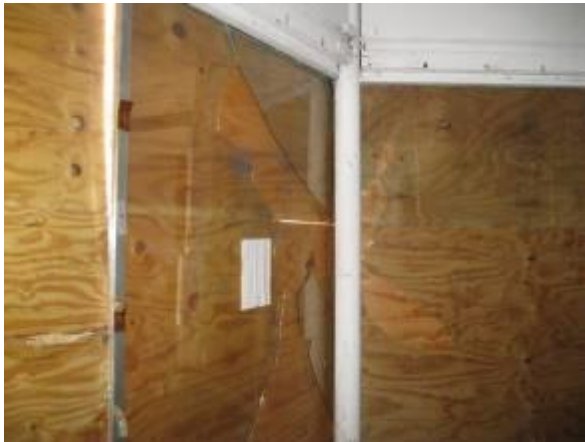
Photo #37 4140- 2 of 4 front single pane glass units broken.

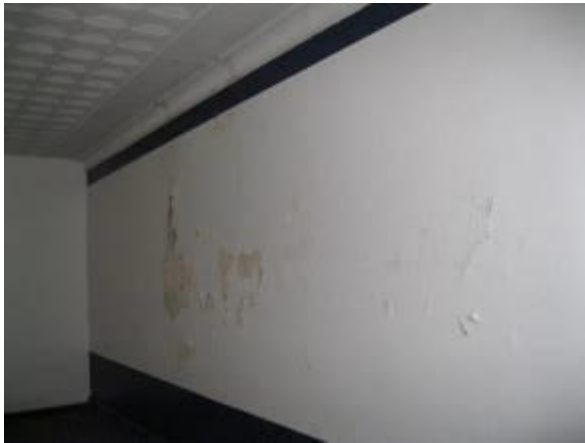
Photo #39 4140- widespread staining and peeling/blistering finishes on south elevation.

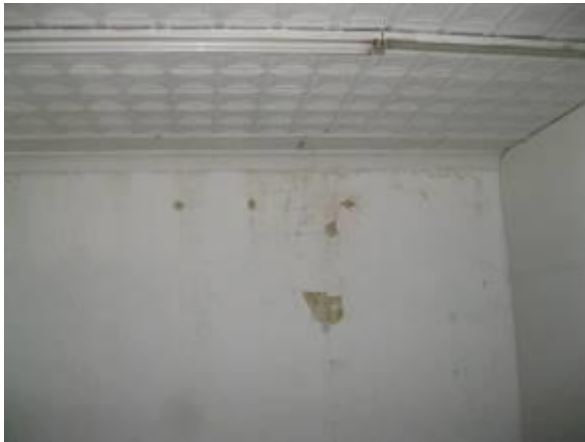
Photo #43 4140- additional staining/ peeling of south wall in rear area.

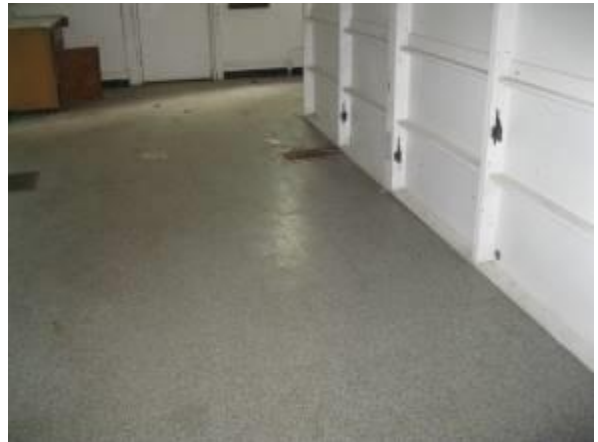
Photo #44 4140- downward deflection of floor in center of rear area.

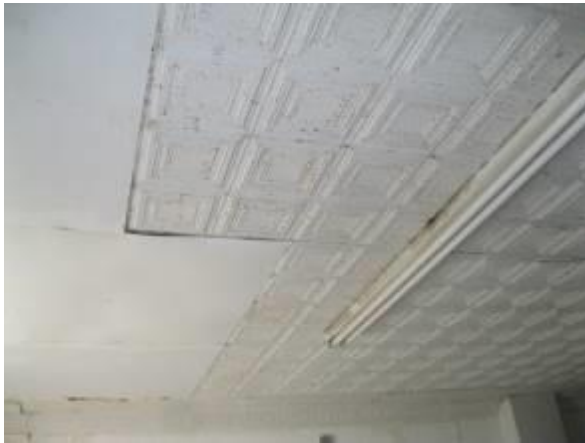
Photo #45 4140- likely corrosion spots scattered across metal ceiling tiles.

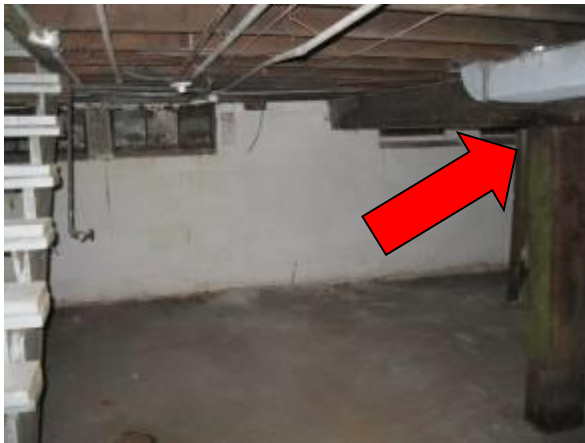
Photo #47 4140- looking towards east (rear) basement foundation; possible settlement of rear column below floor deflection observed above.

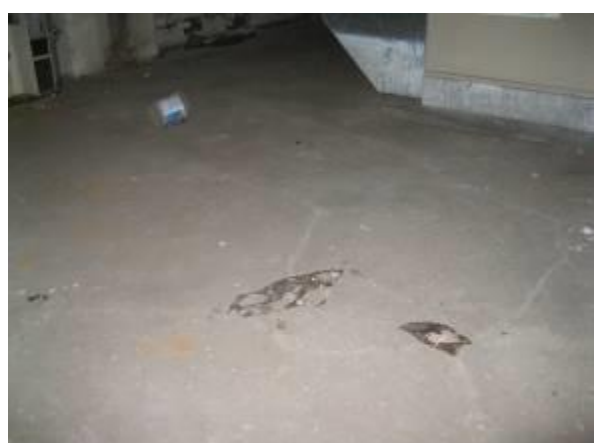
Photo #48 4140- cracks in concrete topping between rear column and furnace.

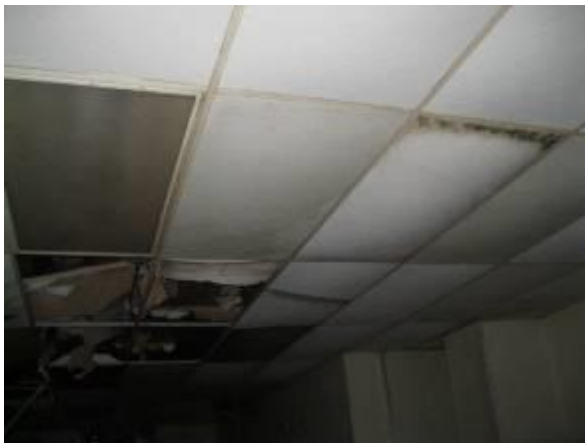
Photo #57 4142- suspect microbiological growth on stained/ bowed ceiling tile adjacent to several collapsed tile in the southeast rear corner of the space.

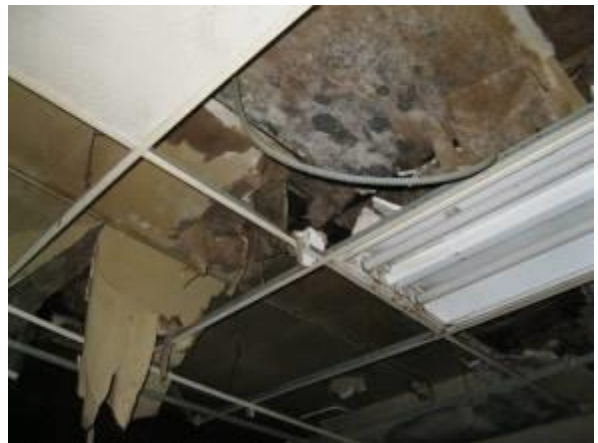
Photo #58 4142- collapsed ceiling tile towards the northeast rear corner of the space.

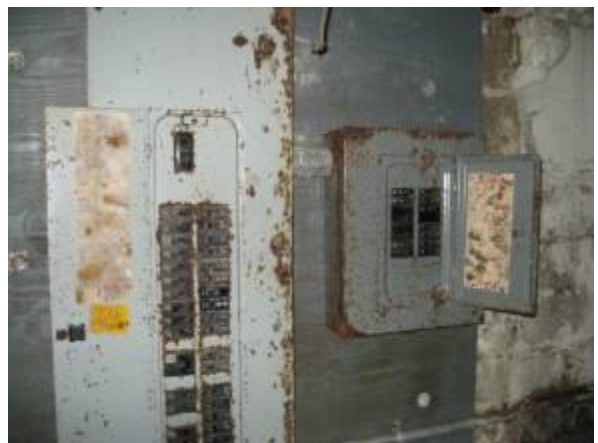
Photo #66 4142- corroded breaker box cabinets.

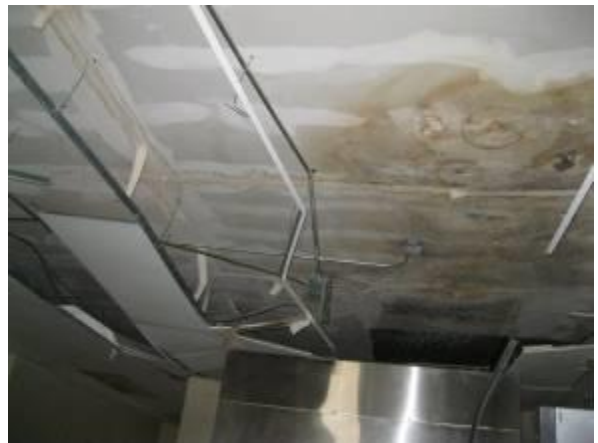
Photo #70 4144- moisture staining of south/ center rear ceiling of main level.

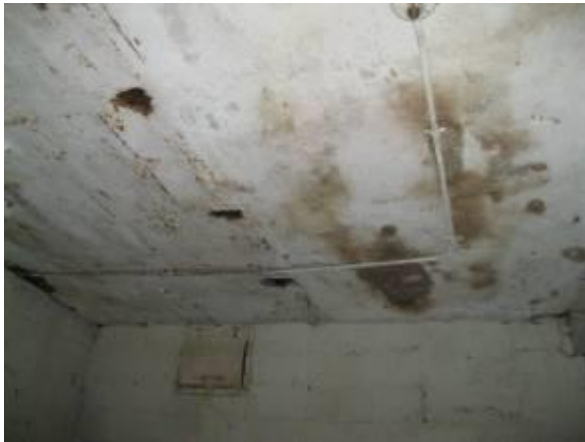
Photo #79 4146- stained basement ceiling below warped sheathing observed in photo 77.

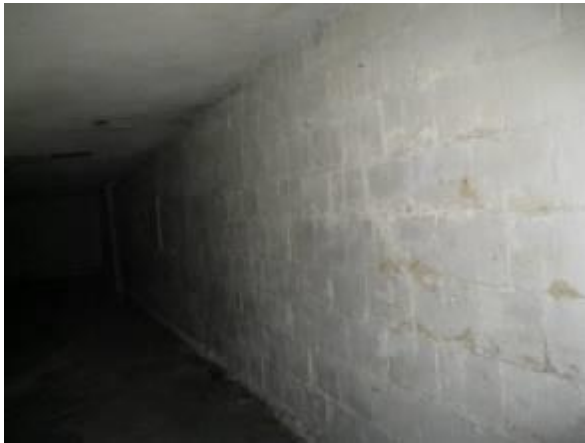
Photo #81 4146- efflorescence along north CMU foundation wall.

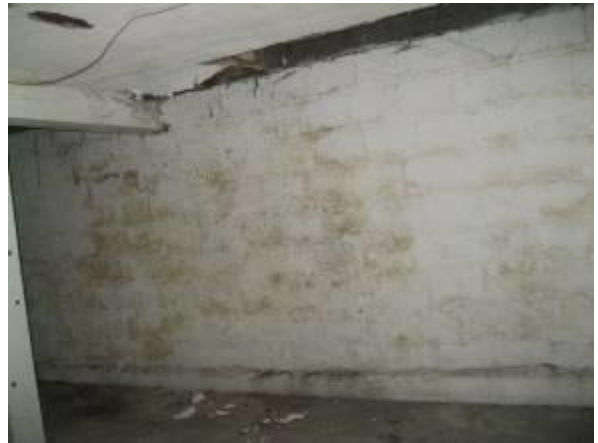
Photo #82 4146- staining and efflorescence on west foundation wall.

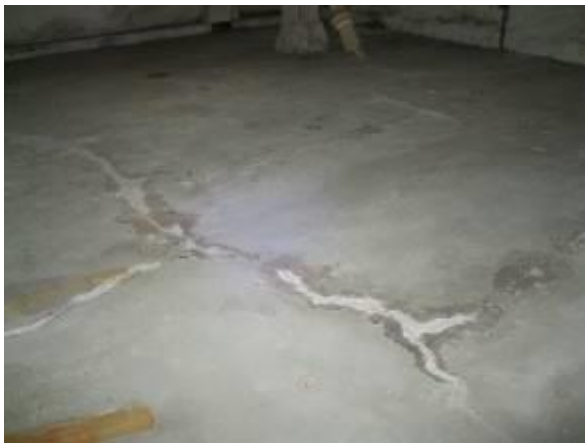
Photo #83 4146- efflorescence permeating up through floor cracks near south end.

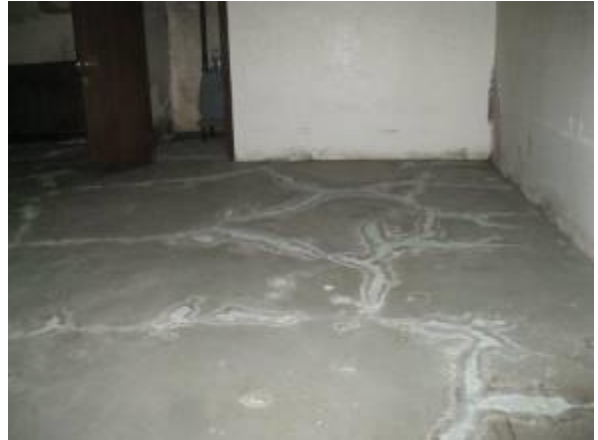
Photo #85 4144-46- mold on rear demising wall in center of basement.

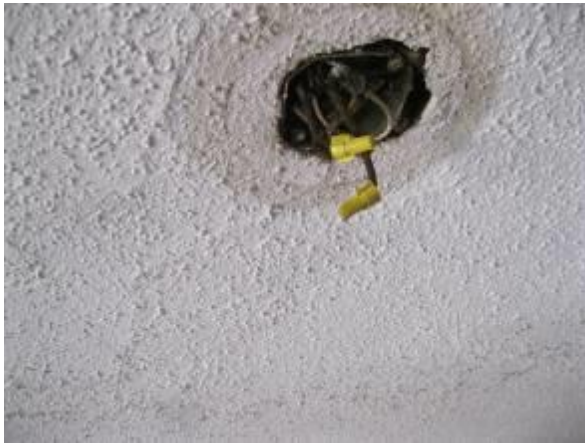
Photo #93 4144-46- southeast corner bedroom; moisture stains at ceiling light fixture.

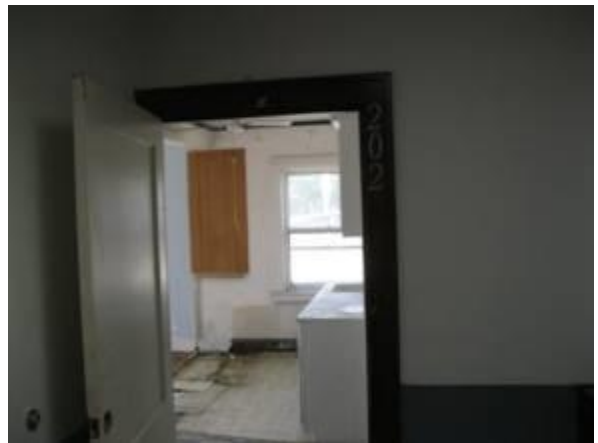
Photo #96 4144-46- southwest corner wall removed between kitchen and living room.
